# Audit for safe accessibility

**CSE has carried out safety audit of six roads with highest number of accidents involving pedestrians and cyclists**

**Pilot corridor: Mehrauli Badarpur road**

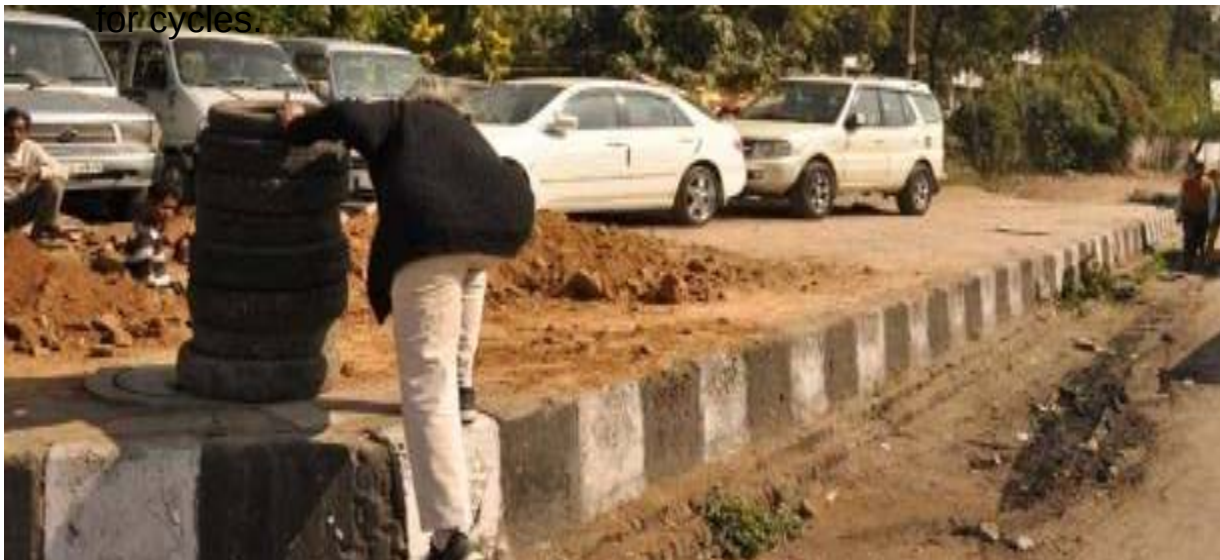
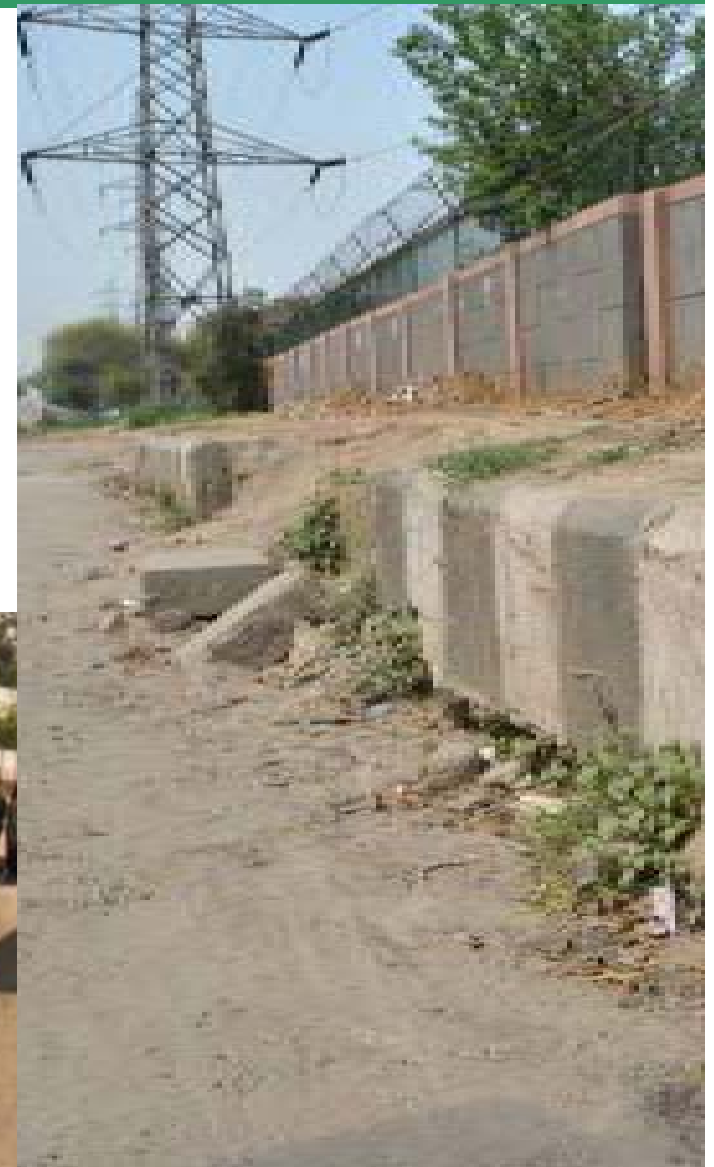
- Footpaths are available in around 55% of the total length surveyed. Only 10 per cent of the total length has cycle tracks: Width of the footpath according to the guidelines is minimum 1.8 M and its available only at 10-15% of the total road stretch. The kerb height is unacceptable along all the roads except at some locations along Vikas Marg. Only 5-10 per cent of the total length has kerb height equivalent to standards i.e. 150MM. None of the corridors have continuous footpath.
- Only 10 per cent of the total length has cycle tracks. Noida Link Road and Vikas Marg have reasonable better cycle tracks but at some segments not accessible due to obstructions at the entry. Mathura road and Mehrauli Badarpur road stretch has cycle track only for 300-400 Mts. There are no legal parking spaces provided for cycles.

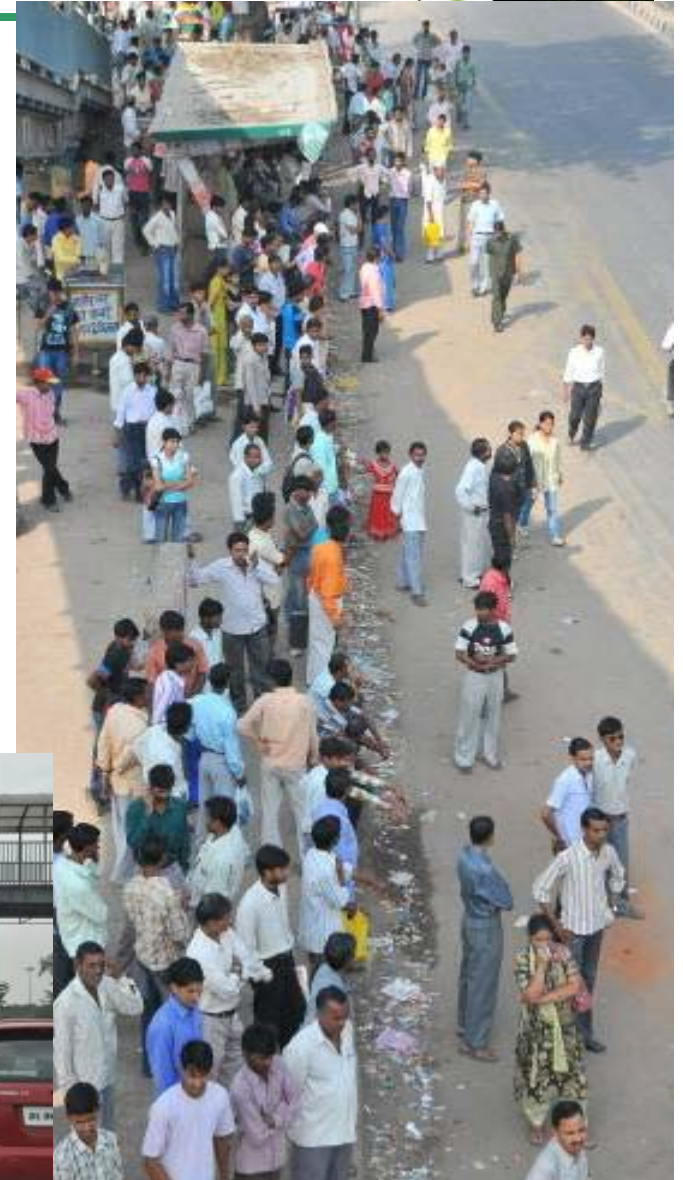
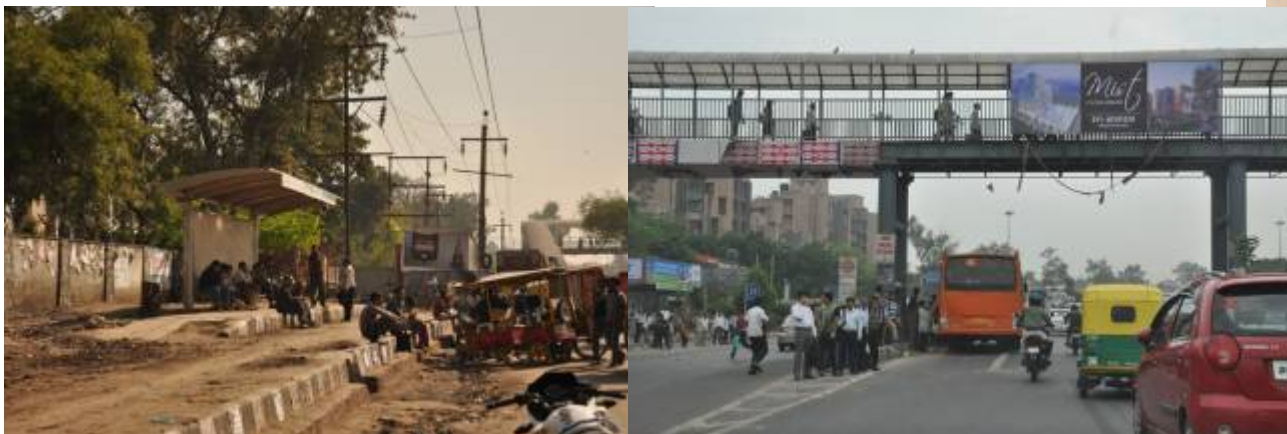
- Accessibility to public transport nodes is poor in almost all the corridors. Bus stops are located on footpaths, as there is no clear multi function zone and have no bus route maps displayed.
- Height of the base of the bus stop does not match with the base of the bus, so people tend to wait on the street as the kerb height of the footpath increases upto 900MM;
- Buses stop at the middle of the road; Roads with more public transport users have less bus stops.
- Bus stops along Mathura road and Ring road are located at the foot of the flyovers so buses tend to stop at the foot of the flyover rather than dropping passengers at Bus stops, making it unsafe for bus users.

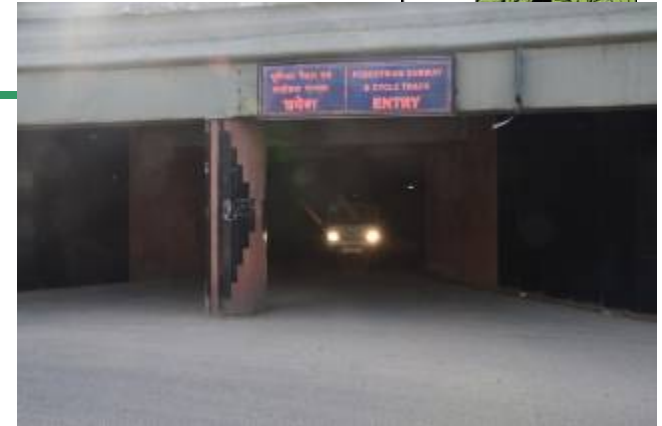
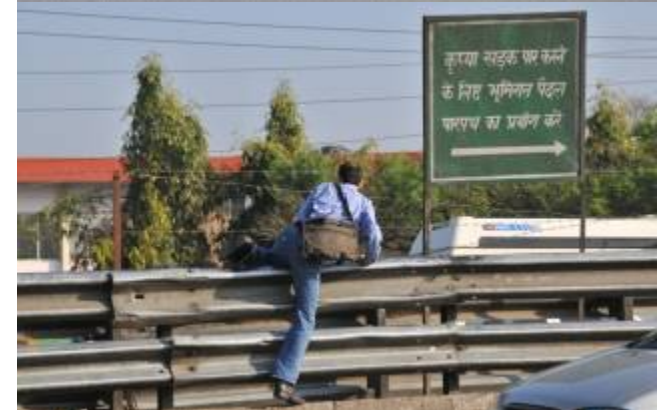
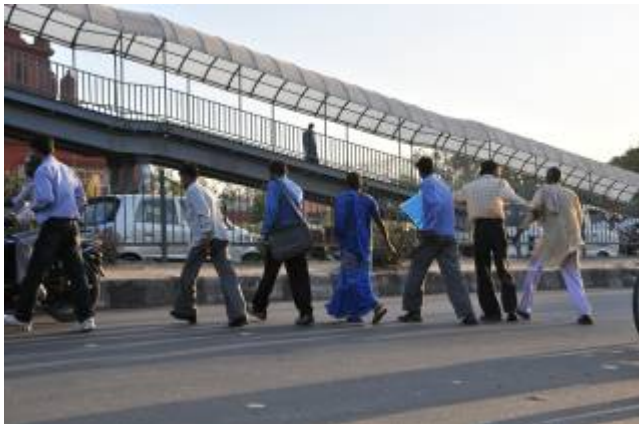
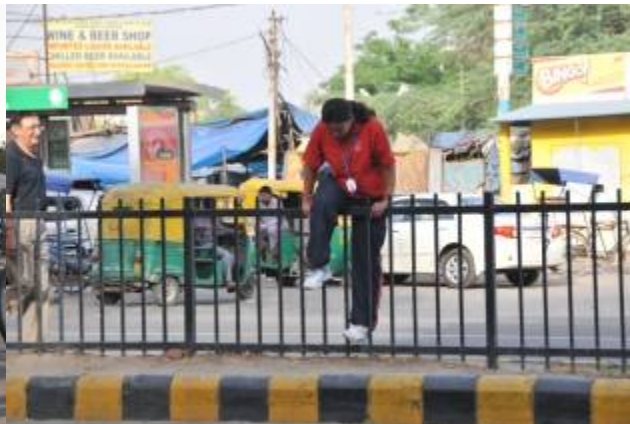
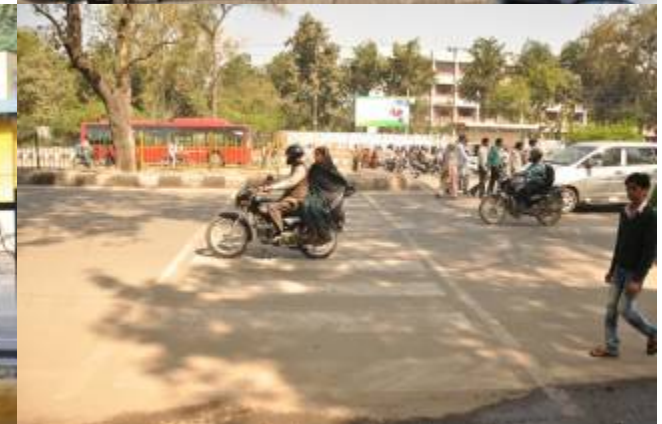
- None of the intersection is designed with raised table top crossings and none have pelican signals for convenient crossings.
- None of the corridors have mid section crossing; Crossing are given either in the form of foot over bridges or subways.
- No crossing on ground for people walking or cycling and medians are blocked with high railings.
- Only 15% of the total corridor studied has visible zebra crossings.
- Opinion survey show 90% of walkers and cyclists prefer crossing on the ground as FOBs or subways increase the distance and are inconvenient.
- Foot over bridges and subways with ramps attract motorized vehicles for crossing.

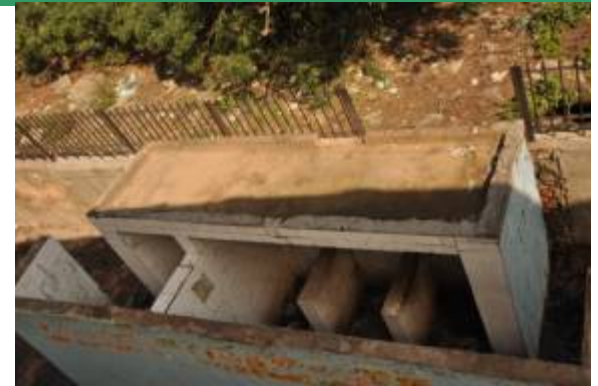
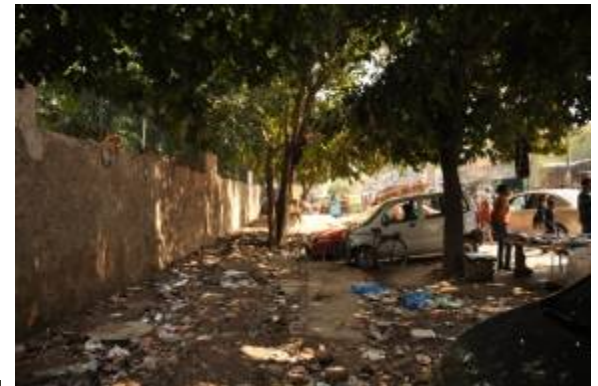
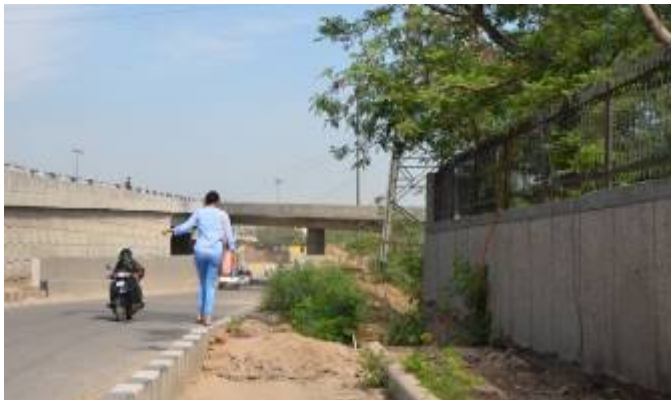
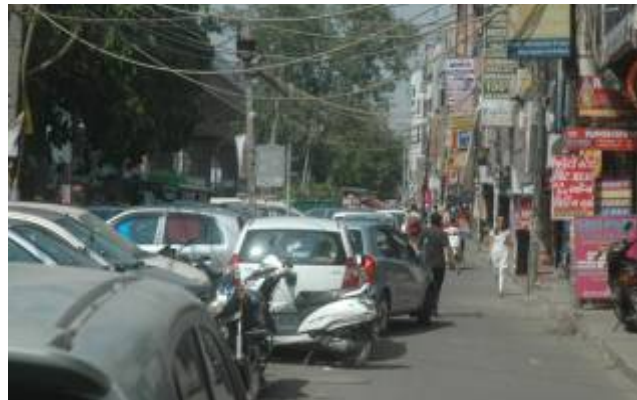
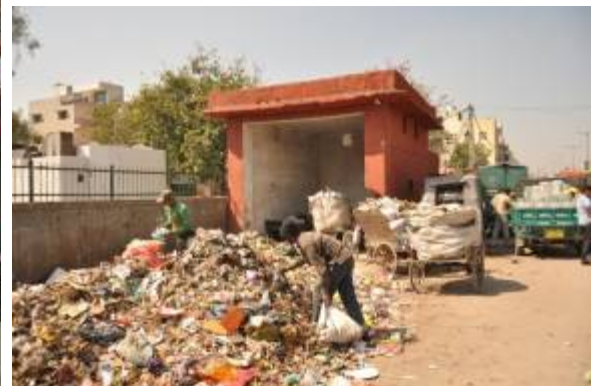
- All corridors score poor even in aesthetics and amenities. Few toilets can be seen along Mehrauli Badarpur road, Noida Link road and Vikas Marg but these remain locked or are in horrible conditions.
- There are no facilities for women. No provision of shaded footpaths. Walking and cycling infrastructure and bus stops are not well maintained and are poor in cleanliness; no concentrated lighting making the infrastructure unsafe in the night.
- Footpaths all along the segments are along the boundary walls with no set backs, making them unsafe and vulnerable to crime;
- Parking on the footpath a menace -- majorly along Mathura road, Mehrauli Badarpur road and Vikas Marg. Around 50% of each road footpaths are encroached by parking.

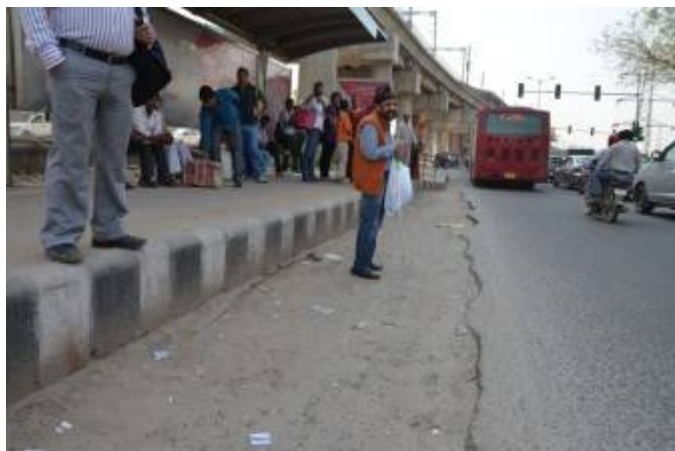
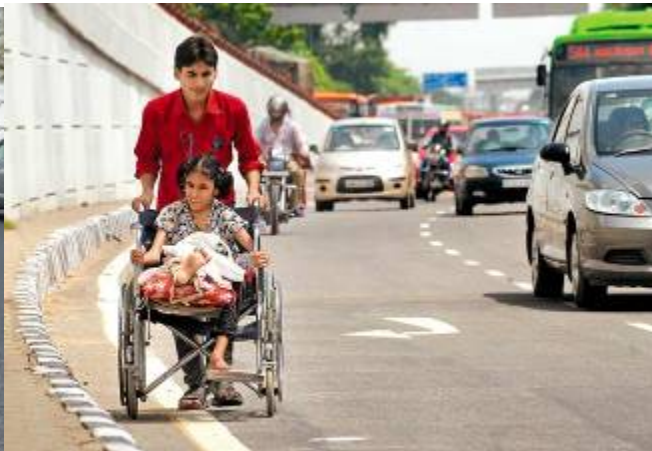
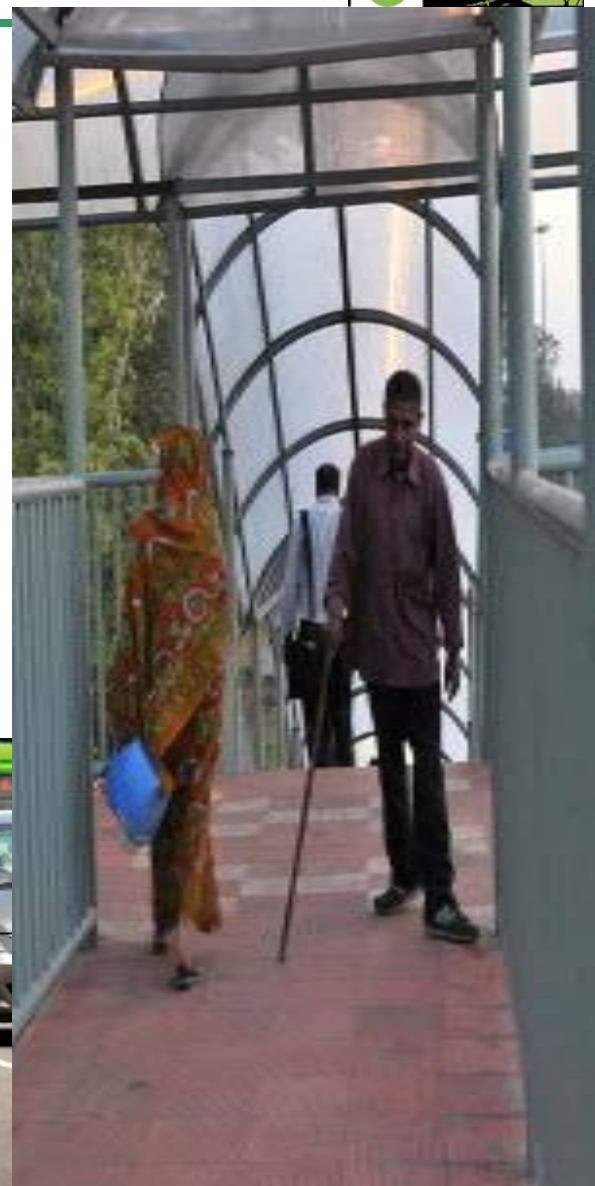
- The infrastructure in all the corridors is not designed keeping disable in mind. All the corridors score zero in this aspect.
- Disabled cannot access footpath as there is no ramp provision and kerb height is higher than 300mm. As there are no raised table top crossings with medians blocked this makes them vulnerable to accidents while crossing;
- Most bus stops do not have ramps or tactile paving; Tactile paving exist along some portions of Ring road, Mathura road and Vikas Marg but they do not lead the user anywhere as they are put in haphazardly manner.
- No provision of auditory signals at any corridor.

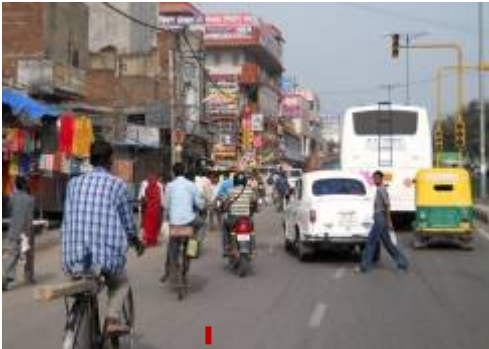
Conflict of various kinds of vehicles occurring at the foot of foot over bridge. Also encroached market shops reduce carriageway width.

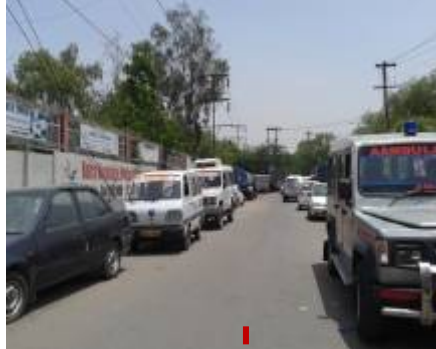
Illegal parking happening all along the service lane along Batra Hospital

Shift unorganised parking from Batra hospital lane and form other stretches to dedicated parking slots to be designated along service lane. The parking will be chargeable

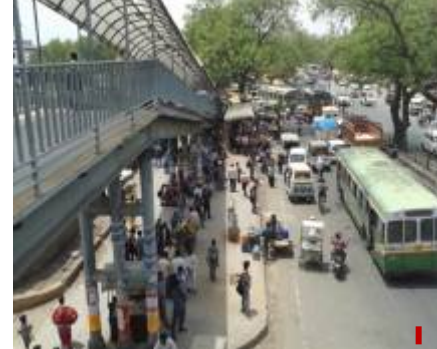
Multiple activities happen at the foot over edge such as auto stops, bus stops etc. leading to congestion

Reorganise hawkers and scattered multi transit facilities. This can free up 800 sq meter of additional area that can be developed as plaza.

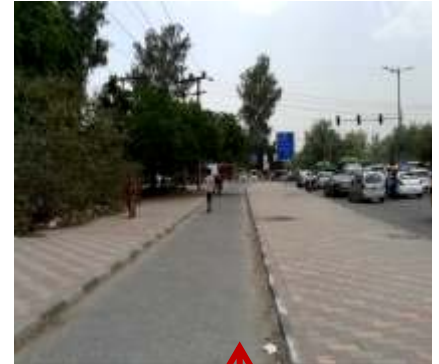
A very small part of the stretch has designed cycle track and pedestrian way.

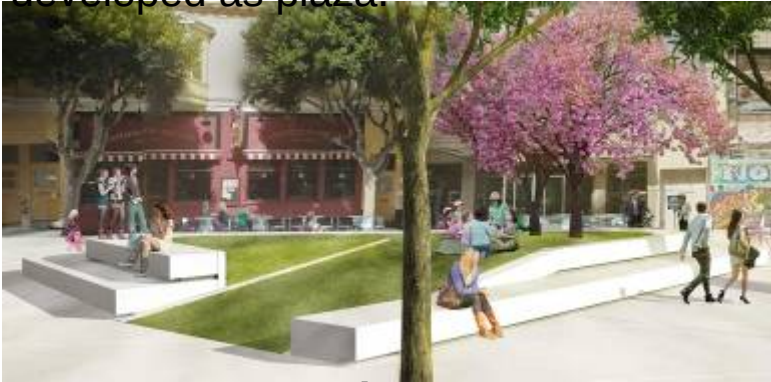
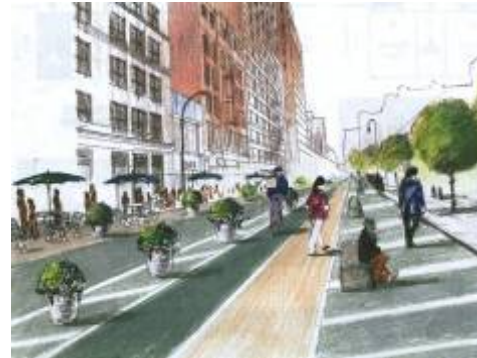
Enough space for linear public plaza (Food Courts, Art and Craft Bazaar etc) between Batra Hospital and Guru Ravidas Marg intersection. The plaza space will have designated hawkers space.

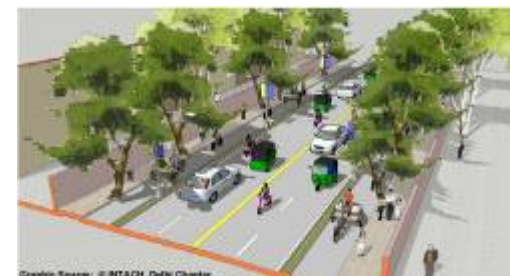
As already planned for BRT corridor, amenities for pedestrians and cyclists to be maintained. The junction and various intersections at present are not designed based on proper standards. The proposal provides planned intersection designs along with treatment of the leftover spaces along with the junction.
