# **Case Studies of Recent Flood Events**

**N.N.Rai**  
**Director, Hydrology (NE)**  
**Central Water Commission**

# Sunkosi land slide dam, Nepal

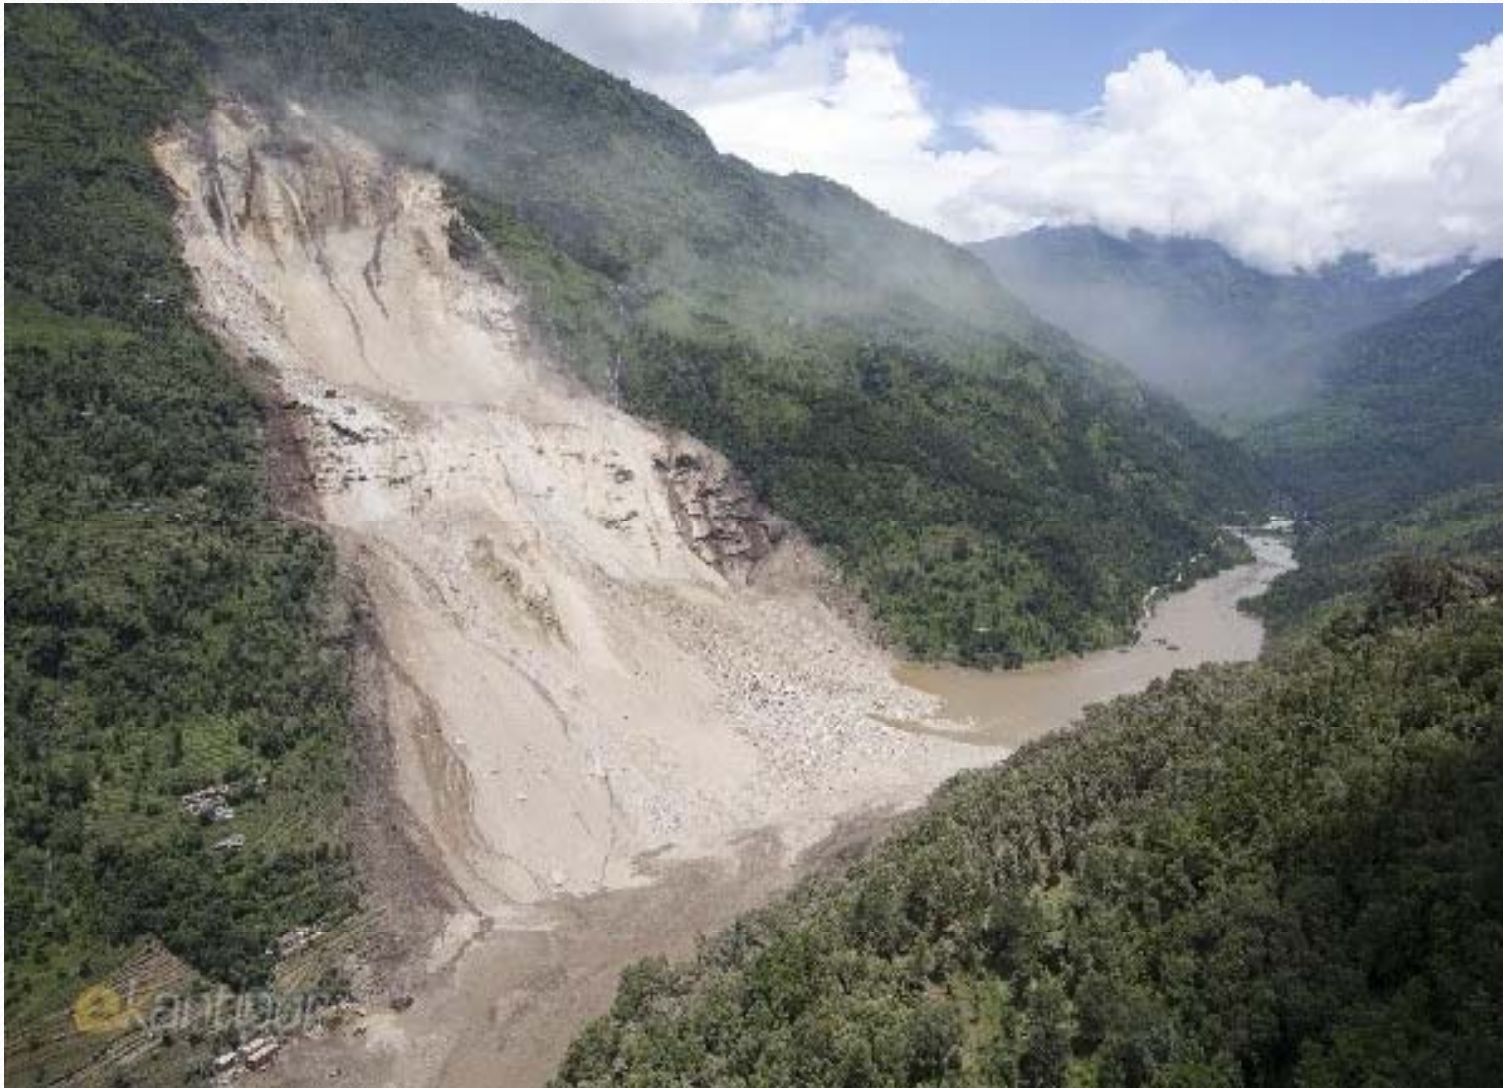
# Photograph of Land Slide Dam

- On the 02.08.2014 at 2:35 AM a major landslide took place in the upper reaches of Sun Kosi river in Sindhupalchowk district in Nepal at a location having latitude:  $27^{\circ}45'40''$  N, longitude:  $85^{\circ}52'08''$  E
- The landslide location is around 1.2 km u/s of existing Sun Kosi Hydro Power Dam and around 11.3 km u/s of confluence of Sun Kosi and Bhute Kosi
- As per the initial information the depth of water column was approximately 50 m to 60 m. The reservoir thus formed submerged the area upto around 4 to 5 km u/s of the landslide location. The volume of the lake was about 2.2 MCM.

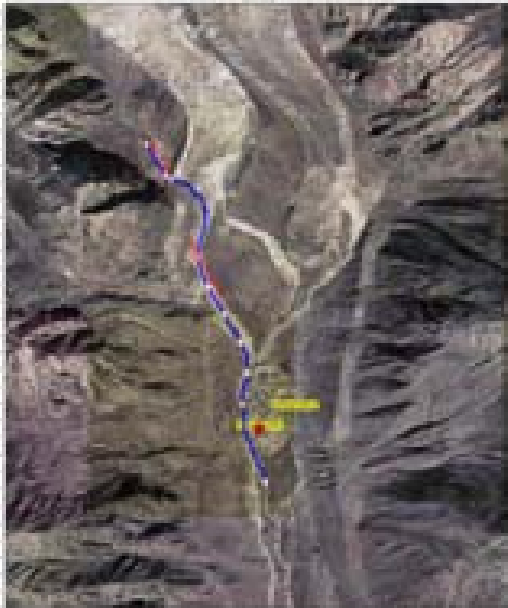
# Lake outburst flood

Discharge  
— MANDAKINI 1300.00

Flow velocity  
— MANDAKINI 1400.00 Velocity
