SAFETY AUDIT OF ROADS FOR PEDESTRIANS

By Dr. Nishi Mittal Head, Traffic Engineering & Safety Central Road Research Institute, New Delhi nishisafe@gmail.com

Design Stage Audits for Pedestrians

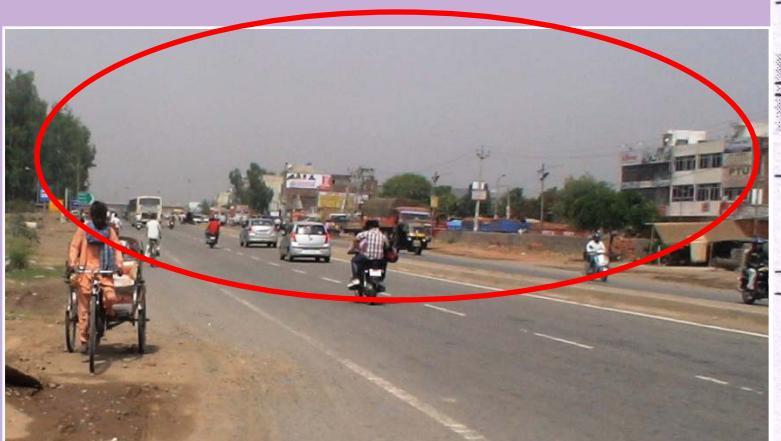
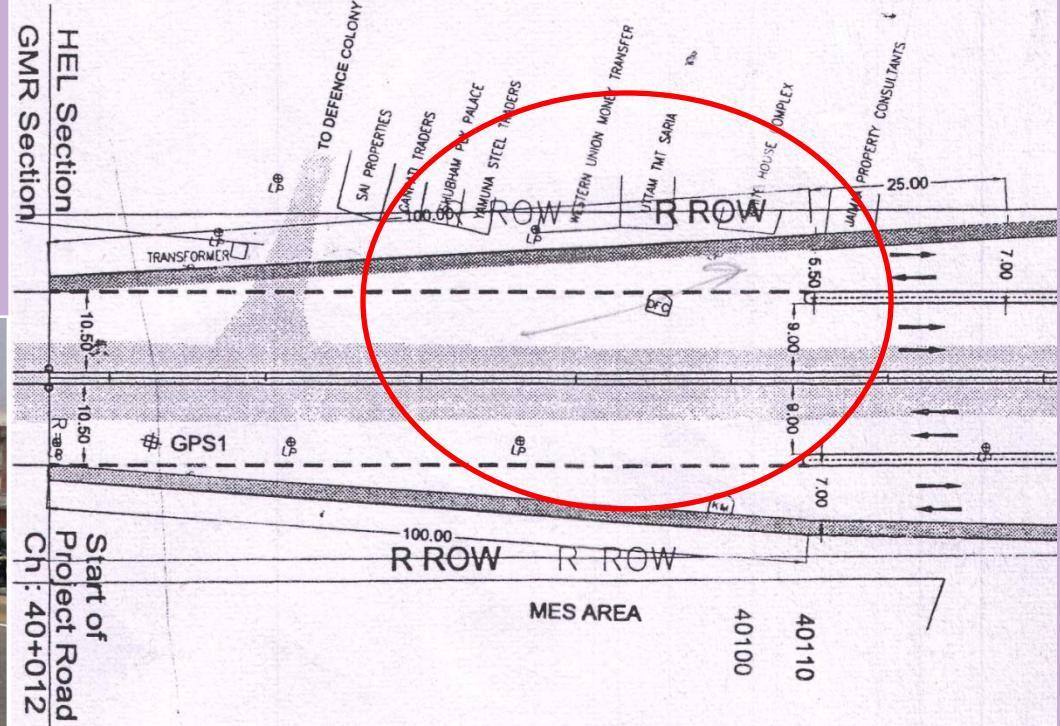
Non provision of Service Road

•Non provision of service road at start of project road can promote lawless movement in hazardous manner because of built up areas.

•Provide service road for safe management of traffic in built up areas from Zeerakpur intersection to start point of project road.

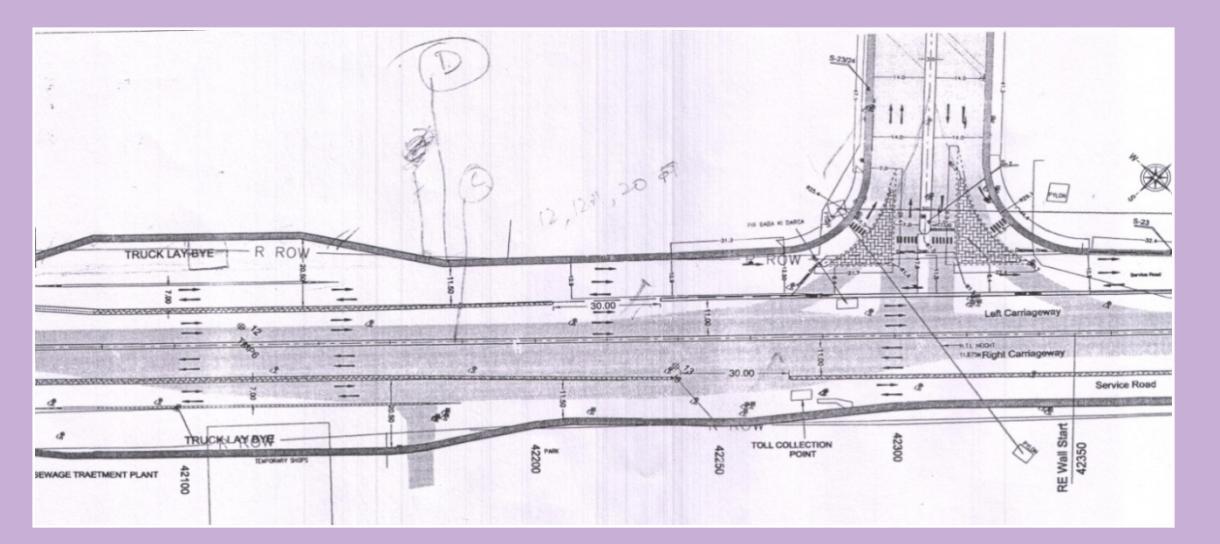
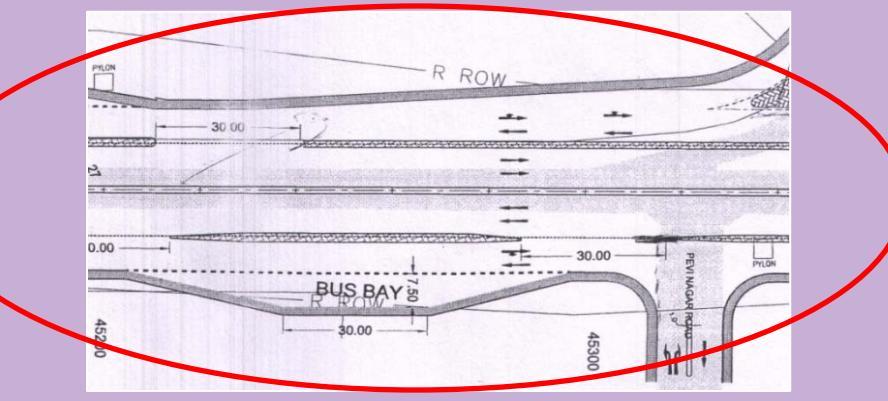
Location of Bus bays too close to Intersections

•It overlaps and conflicts with the Intersection influence area.

•Provide bus bays away from Intersections influence area preferably after the Intersections.

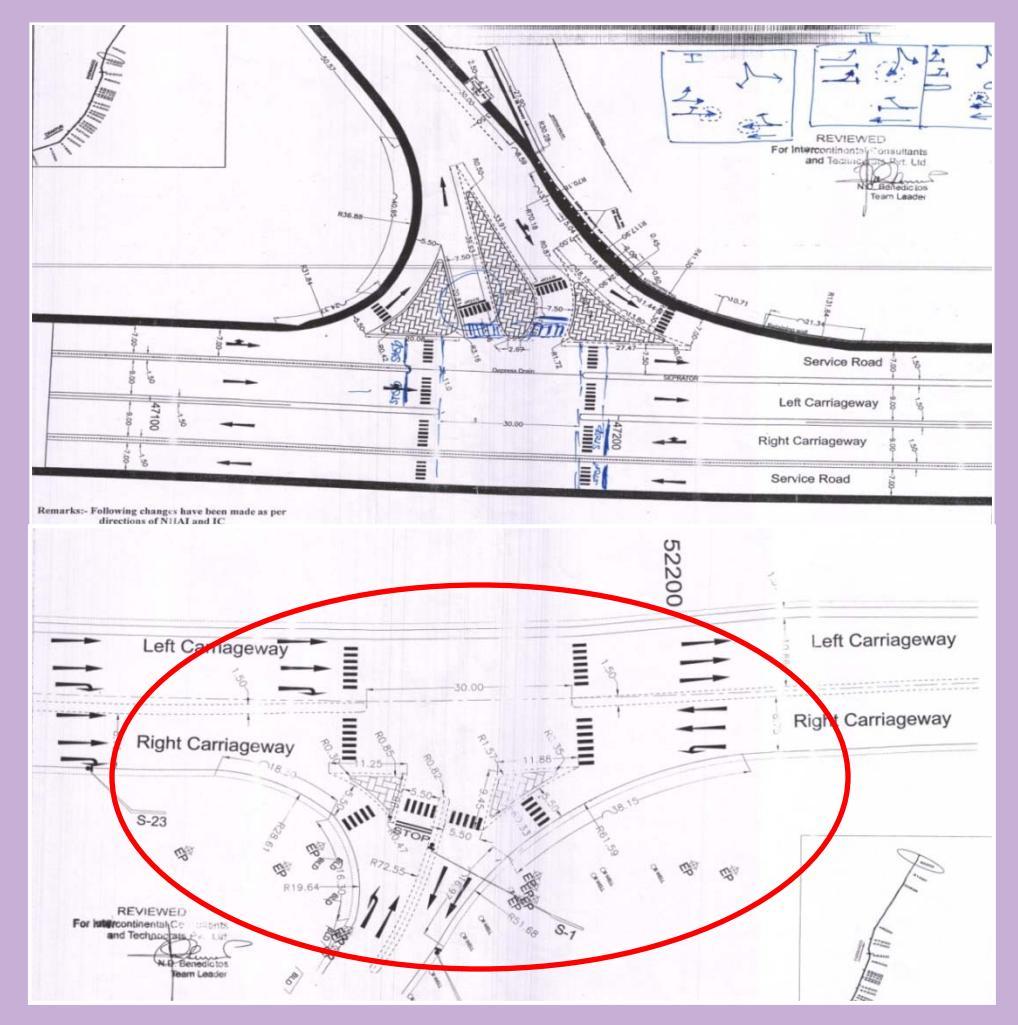
Pedestrian crossing Facilities at Intersections

•Stop line and Pedestrian Zebra crossing not provided properly

•Pedestrian desire line of crossing across the approach roads is not followed appropriately and is not integrated with stop line and zebra crossing markings etc. leading to a situation where pedestrians will try to cross at unauthorized places and put themselves to risk.

• Straight movement along the slip roads can be integrated with that along the main road and extra conflicts may be avoided. Proper pedestrian management / circulation plan with signal phasing be provided.

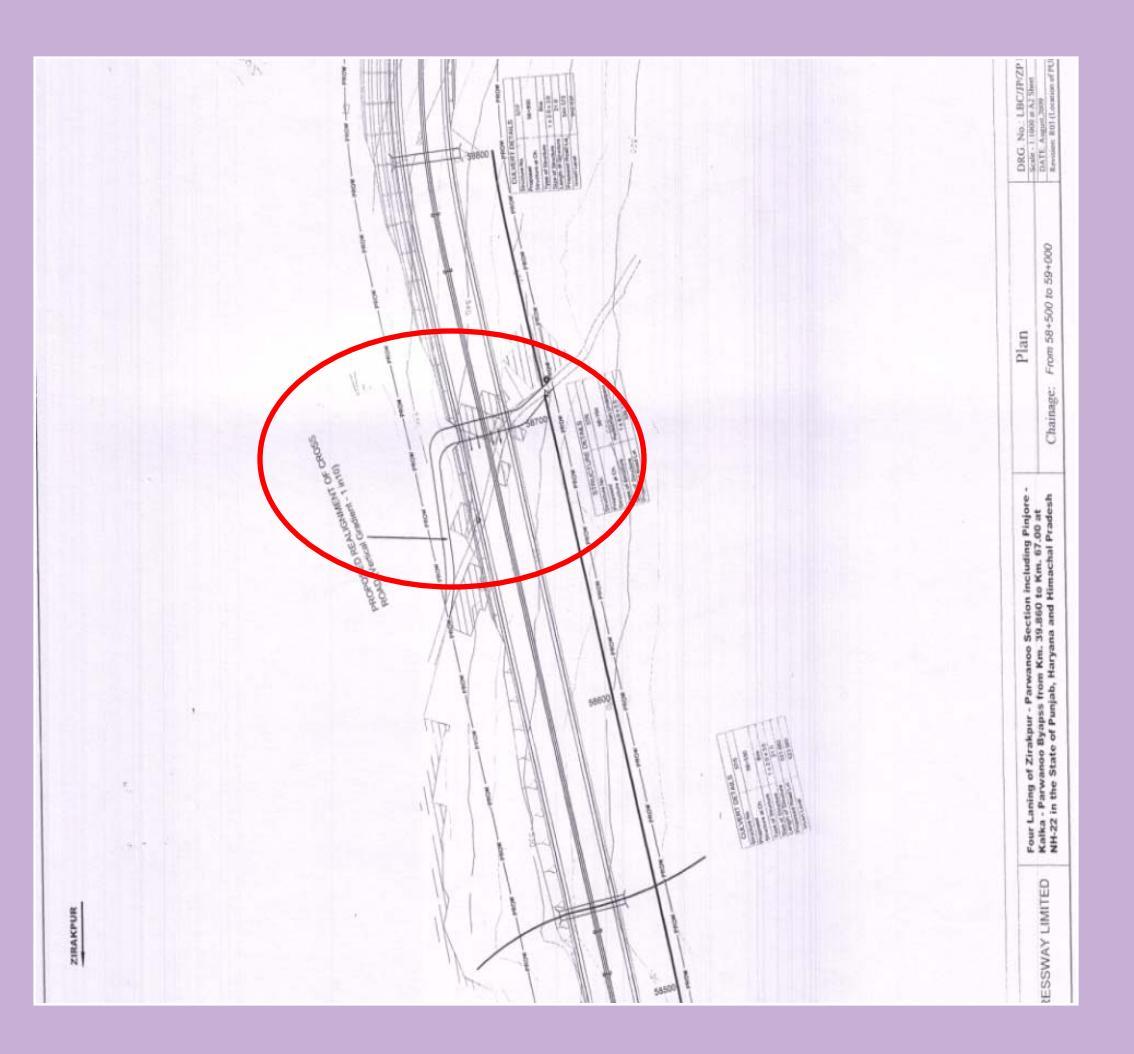
• Proposed PUP at km 58.704 is narrow (1x1.6x2.5) and steep as it will be also used by NMT and 2wheelers.

•Provide wider facility with proper slope to accommodate the expected crossing traffic

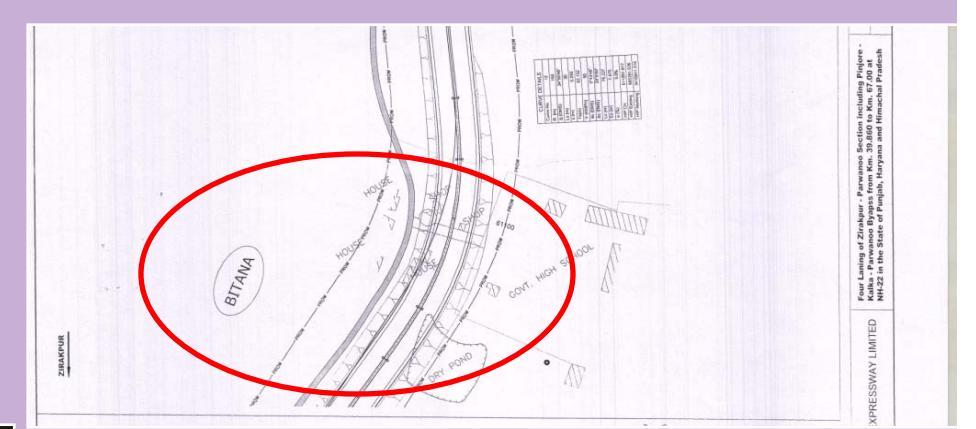
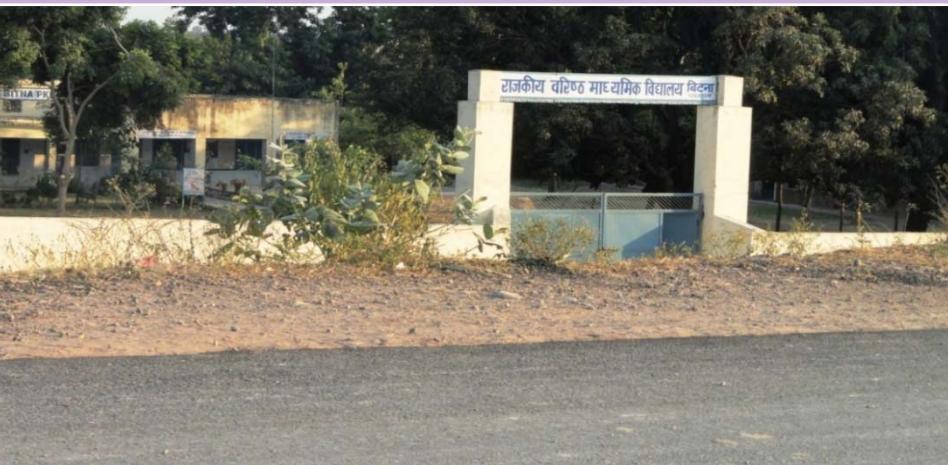
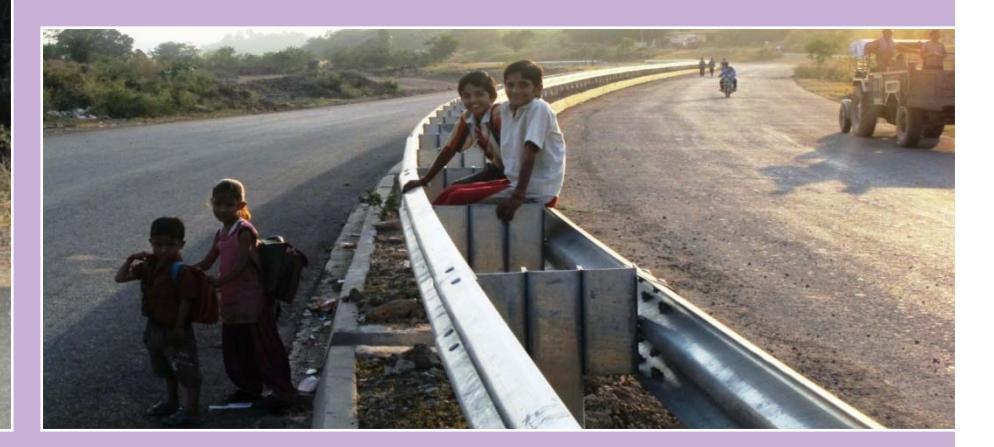
Non Provision of Pedestrians
 Facility at km 60.100 at Bitna
 High School across Project
 Highway.

Pedestrian Under Pass may be Provided as the Project Road is at embankments.

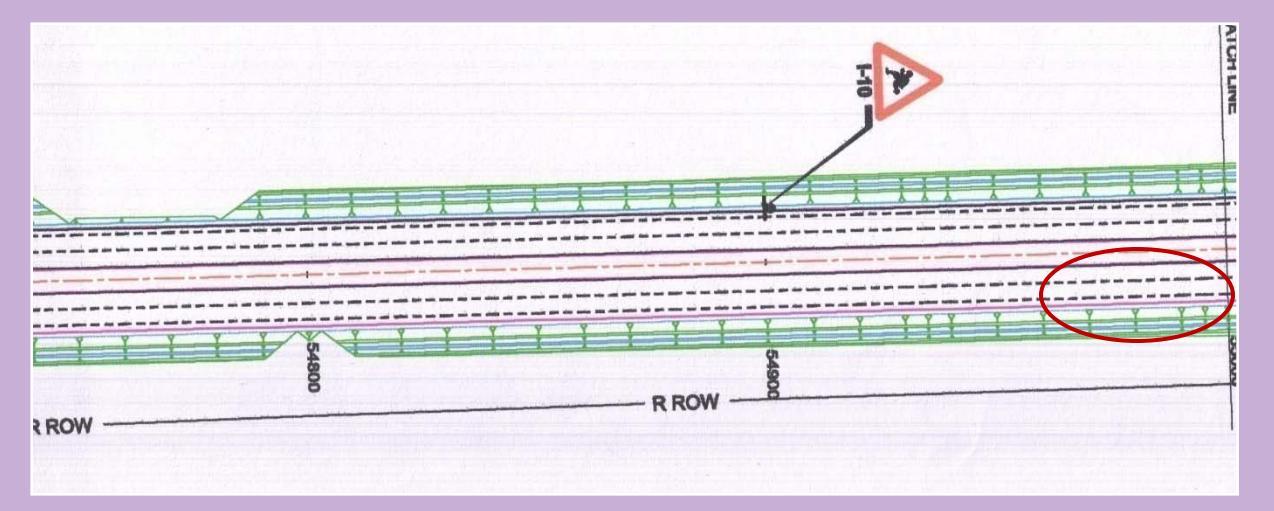
Wrong Signage for "School Ahead"

A school sign is provided at location 54+900 has been shown. It is shown only in direction towards Parwanoo but not in the reverse direction.

<u>Recommendation:</u> Signs for school ahead should be provided on both directions. Also there should be advisory speed limits and "Go Slow" plate advising motorists to slow down while approaching school area.
