MAY 7, 2003

**Report on Visit to Union Carbide India Ltd., (UCIL) at  
Bhopal for the steps needed to remove of toxic waste**

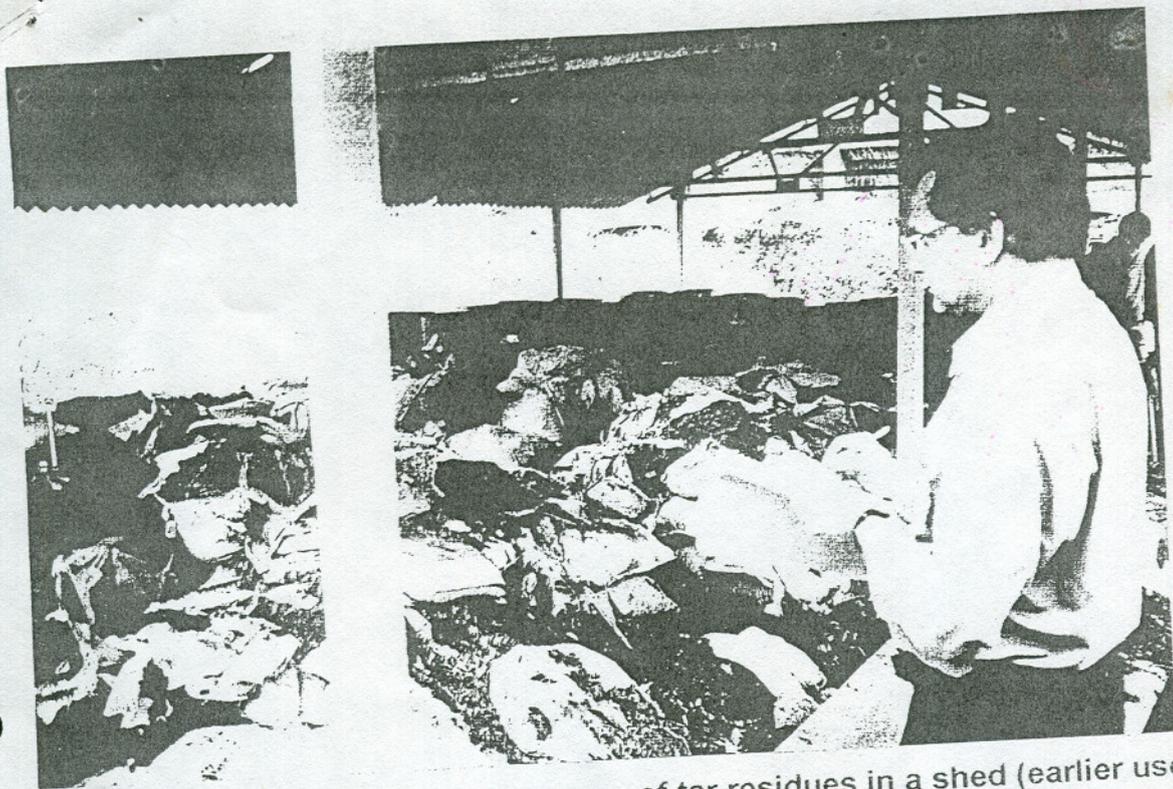
- a) **Storage of tar residues** - The tar residues stored in one of the shed (earlier used as a cycle stand), are kept in polythene bags and mild steel drums. The drums are corroded and bags torn-off. The guard wall of 30 cm height provided in the shed was collapsed on one side and the other side giving way to loose material. There is no signboard to indicate the quantity of stored material. The shed is easily accessible from any side due to low height (30 cm only) of guard wall.

PLATE 1 : Photograph showing storage of tar residues in a shed (earlier used to be a cycle stand). Polythene bags were found torn-off and drums corroded

- i) Immediate steps should be taken for proper storing of tar residues preferably in plastic drums or thick polythene bags, with a raised wall and door(s) with locking arrangement. There should be a signboard for displaying stored material with quantity.
- ii) The tar residue in the sevin plant (due to collapsed reactor) should be immediately collected in drums and brought in one of the sheds.
- iii) The entire boundary wall should be repaired and well guarded with by the security personnel. Proper security of the area should be done to ensure that animals do not enter for grazing and to prevent people entering from nearby areas so as to avoid any contact with contaminated soil and hazardous waste.
- iv) Bhopal Gas Relief & Rehabilitation Directorate, Bhopal, which is in possession of the premises, should ensure proper security.

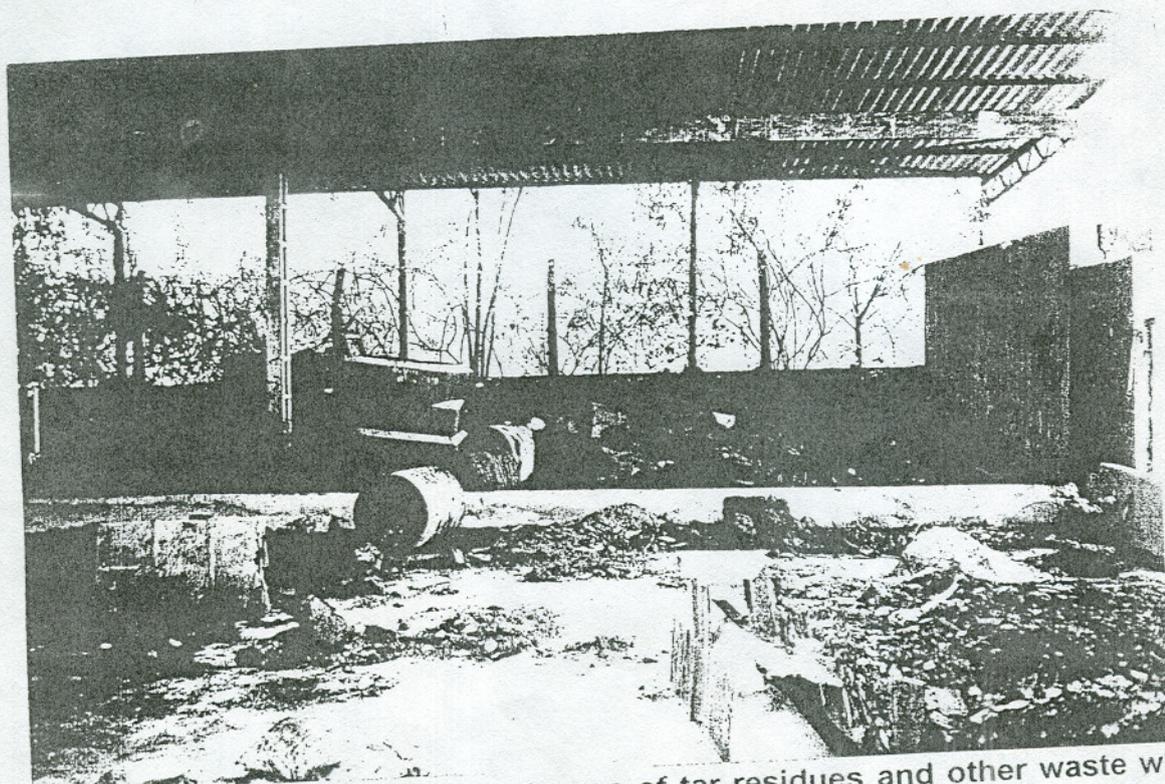
- c) **Storage of hazardous waste** - Another adjoining shed was also seen where materials are stored in loose form on the floor as well as in the corroded drums and torn polythene bags. Some waste material (tar residues) is kept in trays. One of the walls is of 1-meter height only where

door shutter is corroded and lying on the floor. The shed is accessible to any one to come freely. The boundary wall, at a little distance from the shed is having hole for the people to come freely in the premises from the adjoining jhuggi-cluster.

PLATE 2 : Photograph showing storage of tar residues and other waste which are improperly kept in the shed

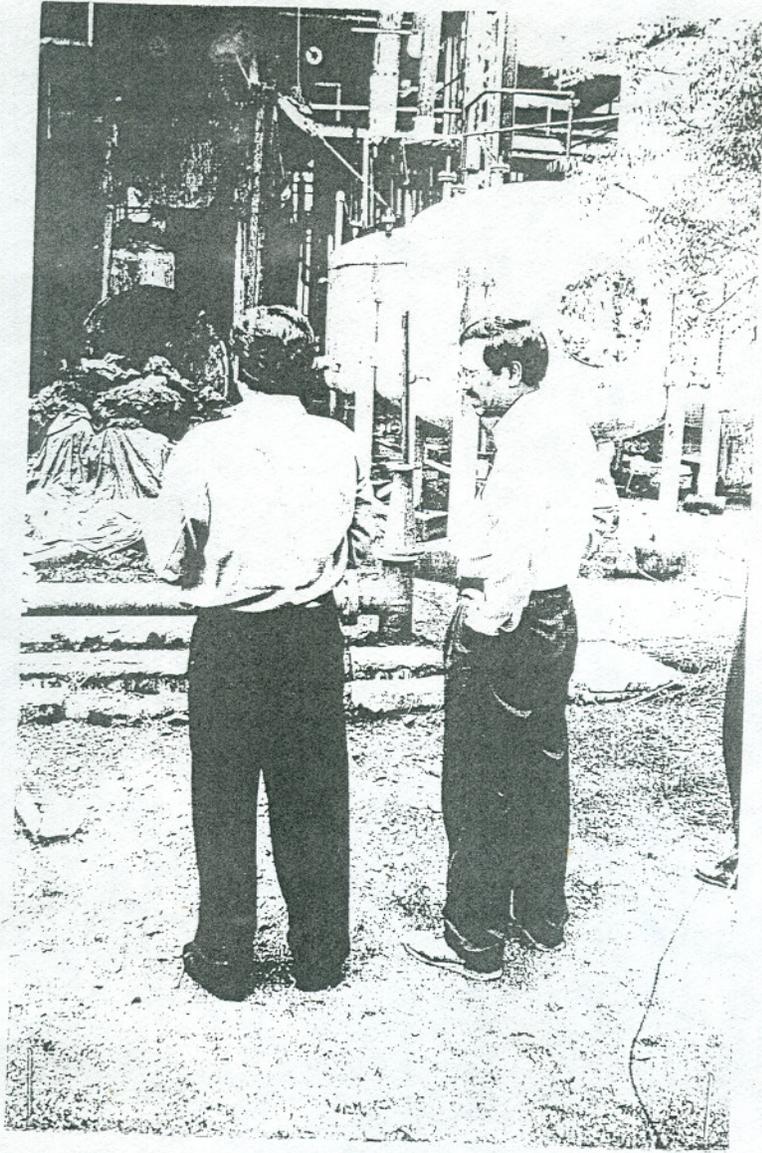
- d) ***Sevin and MIC plant*** - These two plants, which have been constructed on iron structure, are separated by road and open to the sky. The structure as well as plant and equipment are corroded. In the sevin plant, the material (solid and tarry) is spread on the floor due to collapsing of one reactors. Thus, the hazardous material has been exposed, giving rise to contaminated run-off, finding its way to storm water drain. It is reported that this reactor collapsed in June 1999.

PLATE 3 : Photograph showing collapsed reactor and hazardous material spread on the floor of the plant, the run-off which is likely to find way into the storm water drain

- i) As the plant is lying unused since 1984 and badly corroded, the de-commissioning should be taken up without further delay so that spreading

of hazardous material/chemicals due to collapsing of equipment could be avoided.

- ii) Since this is a specialized job, the de-commissioning operation should be executed through an engineering company who is dealing in design and commissioning of chemical plants. The job may be assigned to a specialized engineering company belonging to Govt./ Public Sector like Engineers India Ltd.

- iii) The time limit for de-commissioning needs to be fixed by the Central/State Govt. Since the de-commissioning will involve disposal of chemicals contained in the reactor, tanks, pipes etc., storing of such material, its treatment and disposal should be taken care by such agency.
