DRINKING WATER FOR THE LAST PERSON

TRAINING PROGRAMME FOR RURAL COMMUNITIES AND PANCHAYATS

MADHYA PRADESH

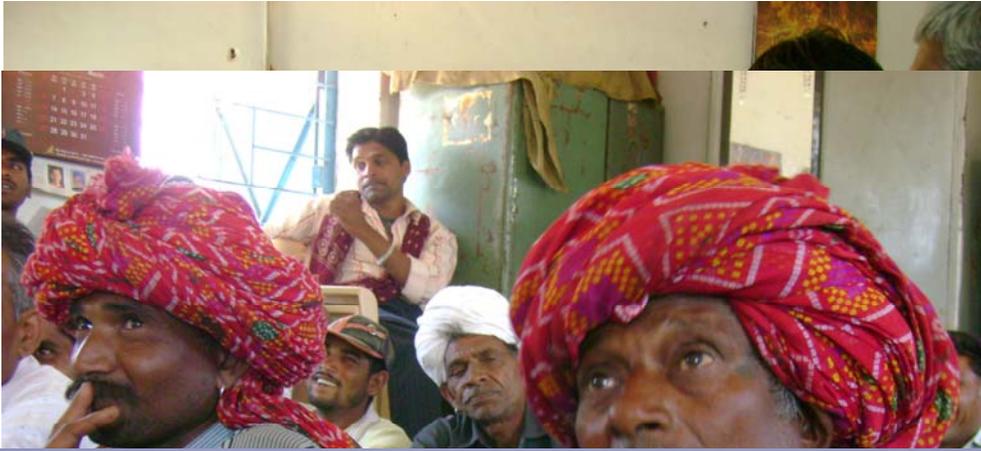
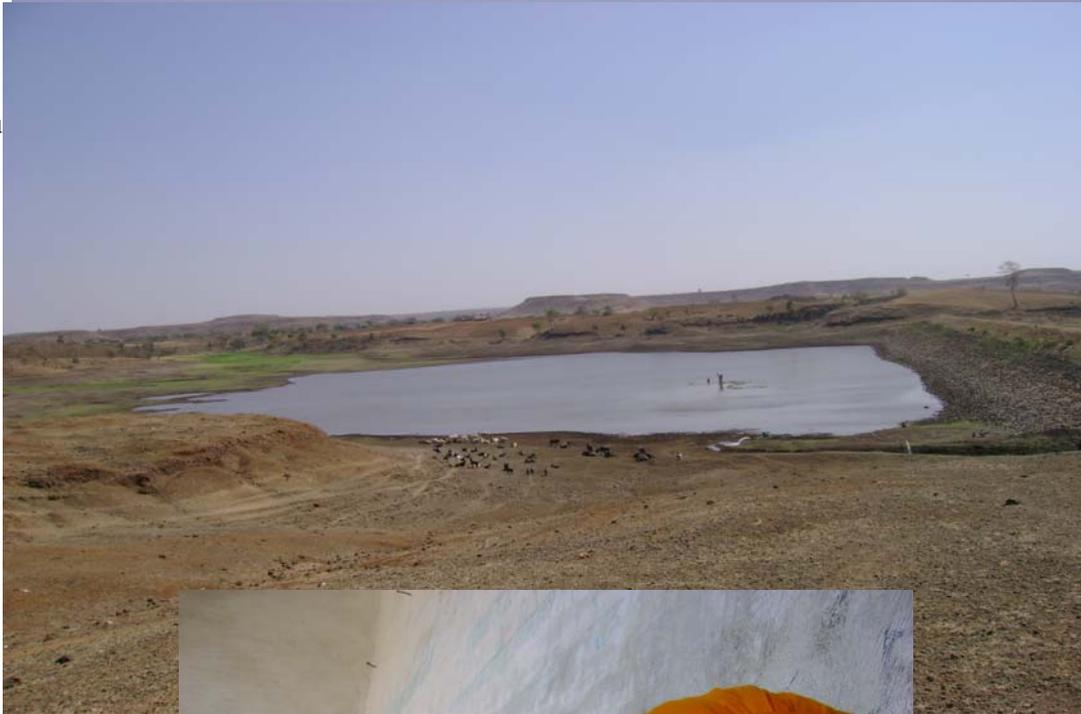
*Village
Ramgarh*

dry
and
denu
ded
land
s

(top)
and
local
pon
d of
the
villa
ge,
used
for
all
purp
oses
(abo

ve)

Surface Water Bodies – the village has 2 small ponds that have water in them only in the monsoon. These were made by the irrigation department and are used up quickly for that very purpose. They also suffer from leakages. There is also a seasonal stream close to the village, which used to be perennial till 20 years back. A stop-dam built on it 20 years ago made water available for irrigation for a few villages around (including Karadavat, the 1st village in this series) and dried up the stream. Water from this stream used to be utilized for all purposes including drinking. Now only irrigation during the monsoon is possible from the reservoir of the dam.

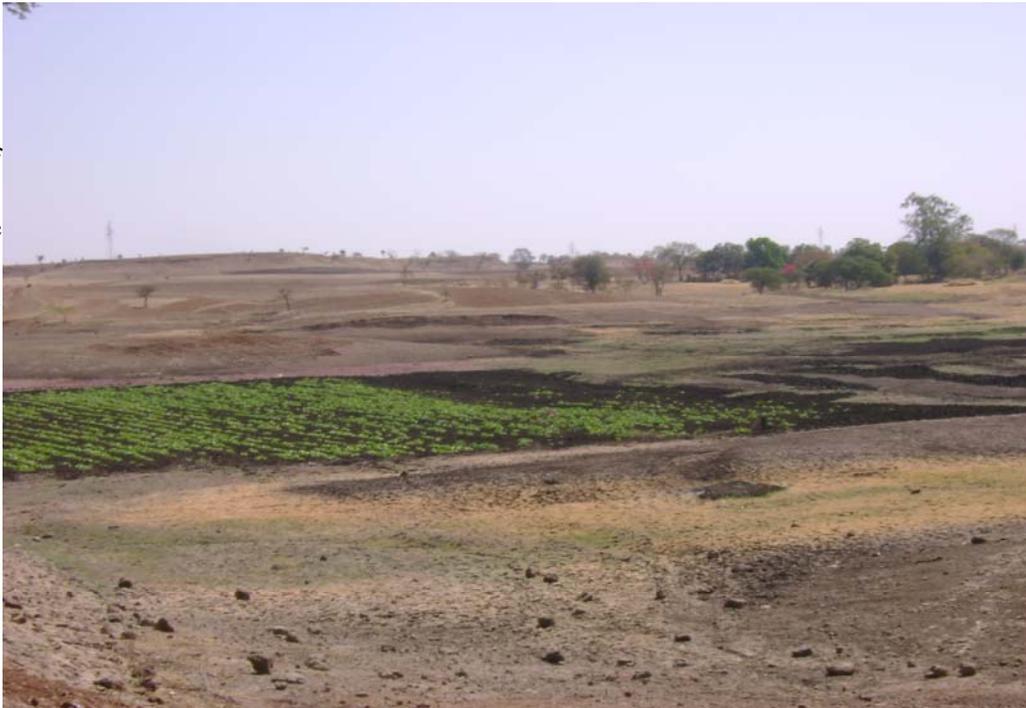
Village Rampuriya

the
pond's
land is
auctio
ned off
in the
summe
r for
agricul
ture

Surface Water Bodies – the village has 1 pond that used to have water throughout the year earlier but now holds water only in the monsoon. It suffers from leakages and less rainfall has limited the supply from the source. When it is dry, its land is auctioned for agriculture. There is also a seasonal stream in the middle of the village, which used to be perennial till 10 years back. A check-dam has been built on it. Water from this stream used to be utilized for all purposes including drinking. Now
